Special Report 81-34

SEA ICE RUBBLE FORMATIONS IN THE BERING SEA AND NORTON SOUND, ALASKA

UNITED STATES ARMY CORPS OF ENGINEERS
COLD REGIONS RESEARCH AND ENGINEERING LABORATORY
HANOVER, NEW HAMPSHIRE, U.S.A.

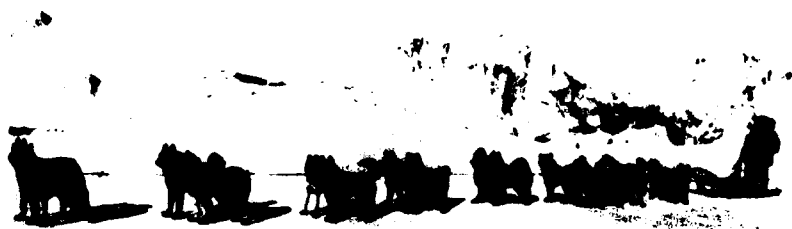
b. View of a grounded ice formation near Nome, Alaska, in spring of 1910.

Figure 1. Photographs of Bering Sea pressure ridges taken in early 1900s (courtesy of G.K. Sherrod, Nome Museum).

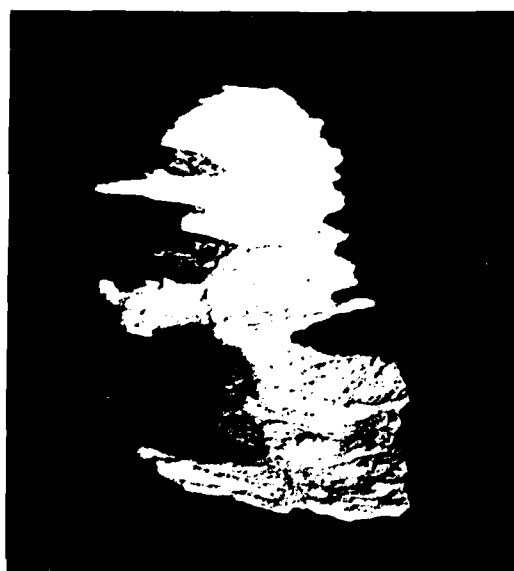
a. Fragments of broken ice exist along fast ice edge at bottom of photograph.

b. Close-up aerial views of the two ice formations shown above.

Figure 3. Two ice ridge formations believed grounded on ribbon-like shoals off the Yukon River Delta.⁵

fast ice surrounding the Yukon Delta there was an open water area, in the center of which (position A in Fig. 2) were several large grounded ice formations (Fig. 3). Bathymetric maps show shoals in this area which rise to within 5 m of the surface.

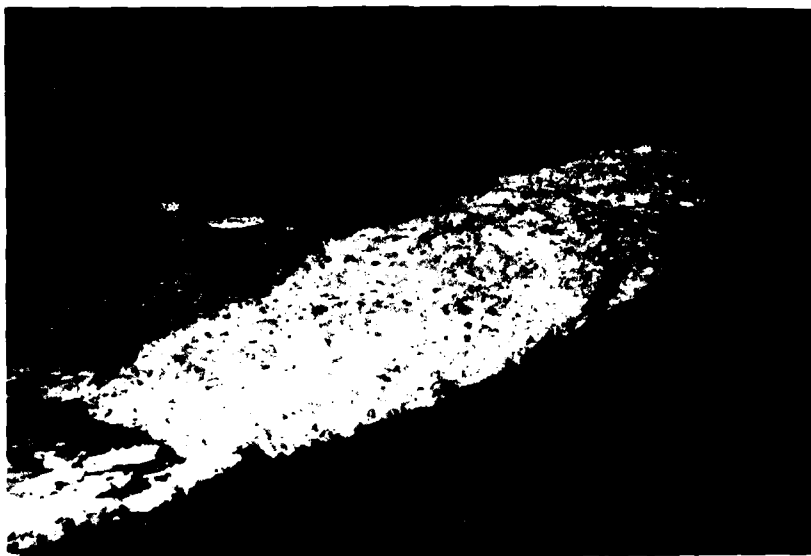
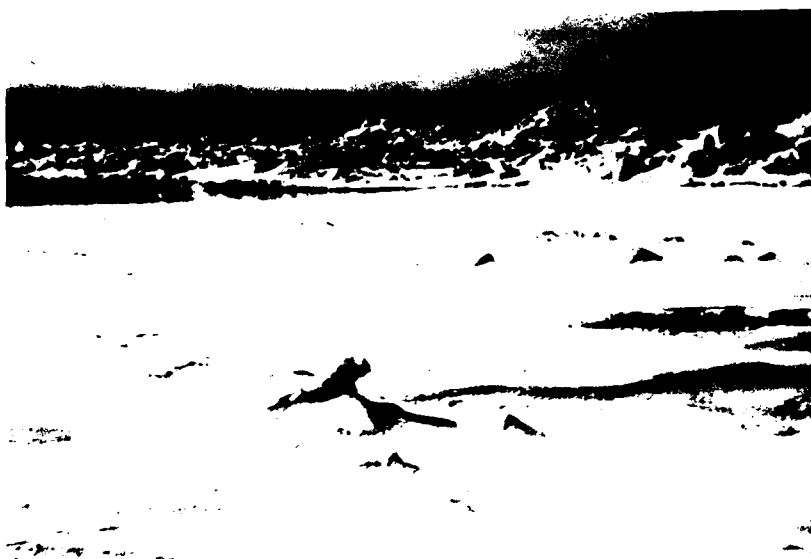
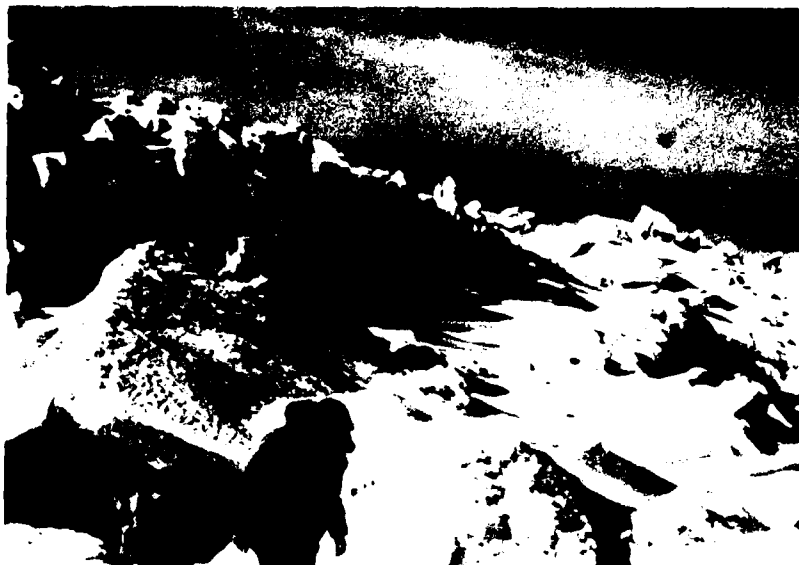
Figure 4. Grounded ice formation one.

a. Aerial view.

b. Ground view (arrow points to man).

c. Close-up view showing ice block thickness variation and dirt incorporated in the ice rubble.

The first ice rubble pile visited is shown in Figure 4. The fast ice was in contact with this formation only at the southeastern end. Drift ice along the north side was estimated to be moving westward at 3 to 4 knots. The formation was estimated to be 75 m wide and over 250 m long. It consisted of ice blocks typically 35 cm thick, but many ice blocks over 1 m thick were noted (Fig. 4c); the thicker ice consisted of previously ridged and rafted ice fragments. The ice formation was grounded in 4.1-m-deep water and reached a height of over 14 m.

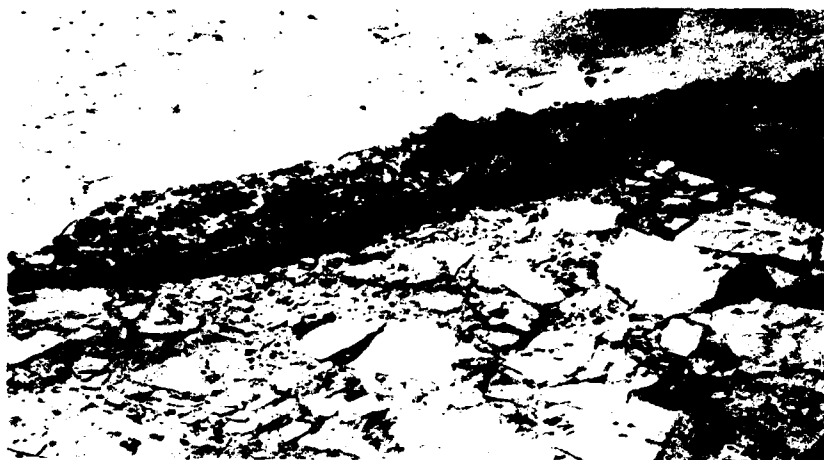
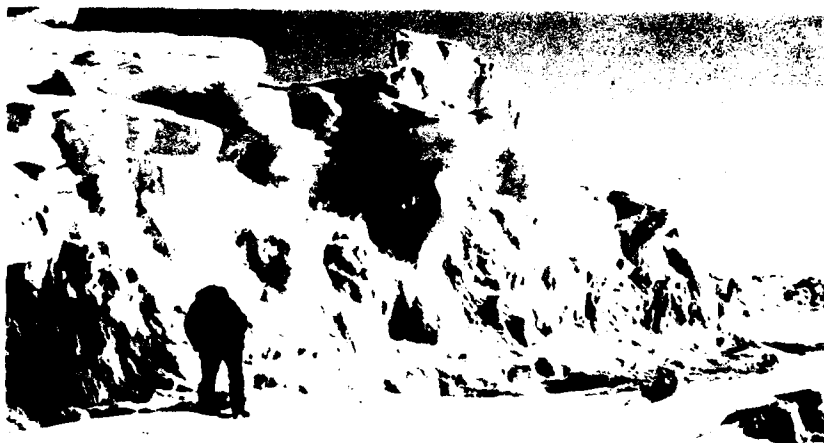
a. Looking south.

b. Surface view of the south face of the ice rubble.

Figure 5. Grounded ice formation two.

Ice formation two (Fig. 5) was grounded in 6.0-m-deep water and was 12 m high.

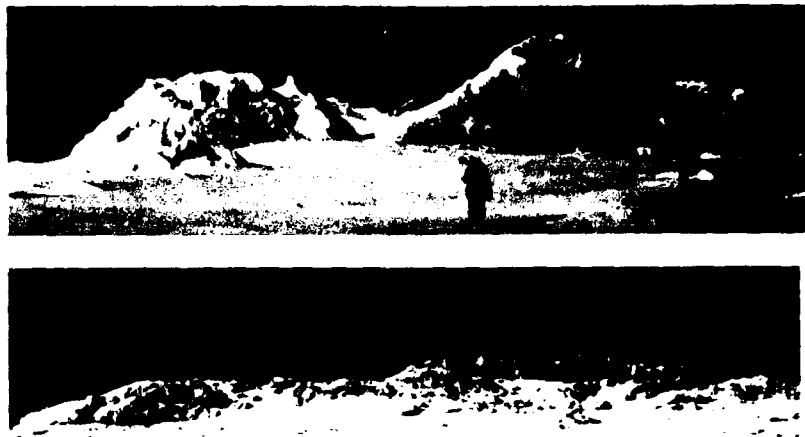
Figure 7. Grounded ice formation four (top). Note man on top of ridge and dirt incorporated in the ice rubble (bottom).

Ice formation four (Fig. 7) comprised ice blocks 25-30 cm thick; it had a ridge height of 13 m and was grounded in water 7.5 m deep.

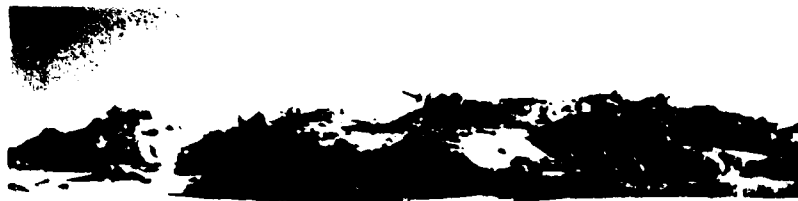
Figure 9. Grounded ice formation six. Arrow points to man.

Ice formation six (Fig. 9), also estimated to be 75 m by 200 m, was 14 m high and grounded in 6.2 m of water.

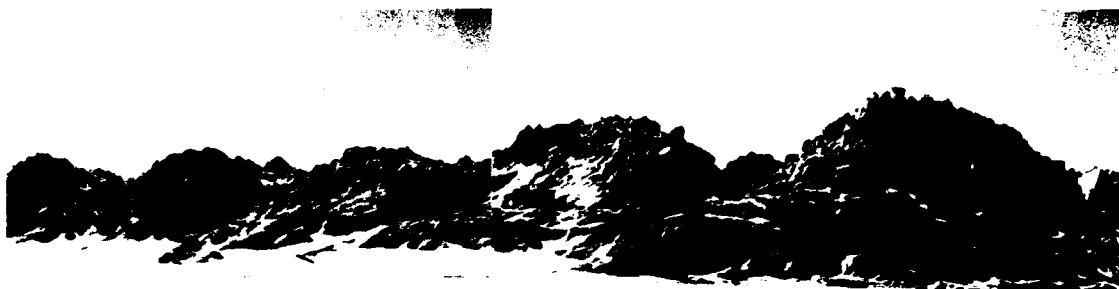
Figure 12. Grounded ice formation eight. Note ice rubble and dirt.

Ice formation eight (Fig. 12) was grounded in 3.0-m-deep water. It was approximately 150 m by 200 m in size and had a peak ridge elevation of 11.5 m.

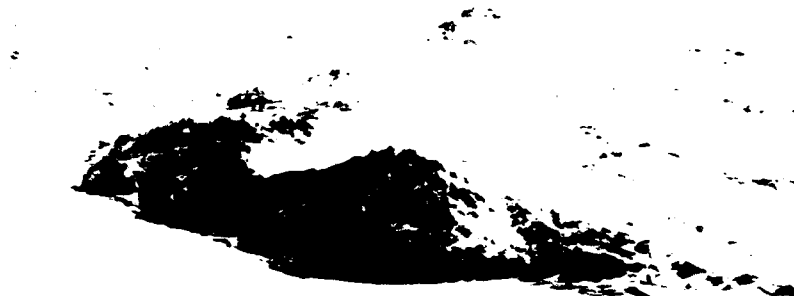
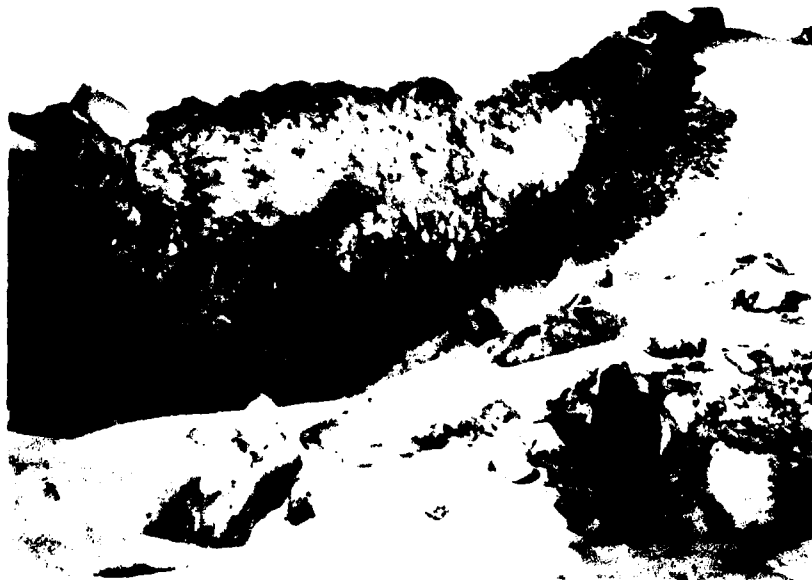
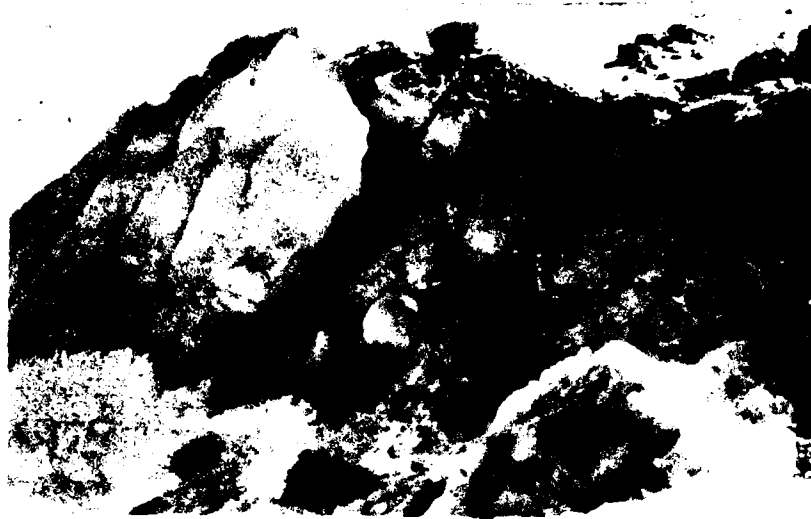
Figure 15. Grounded ice formation eleven.

a. Aerial view.

b. Refrozen fragmented ice in ridge core.

c. Portion of original ice sheet.

Ice formation eleven (Fig. 15) was 9 m high and was grounded in 8.5-m-deep water near position C in Figure 2. Collapse of a portion of the ridge revealed a core of fragmented ice blocks refrozen into a solid mass (Fig. 15b). On the left side of the ice formation the

30-cm-thick ice sheet from which the pressure ridge formed could be seen (Fig. 15c).

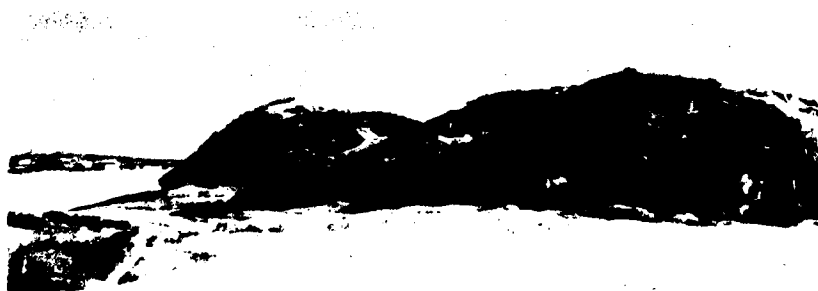
Figure 16. Air (top) and surface (bottom) views of grounded ice formation near Stebbins. The village is along the coastline at upper left in both photographs.

We also observed grounded ice formations in fairly sheltered locations, such as one over 3.5 m high in 3.9 m of water near the village of Stebbins (Fig. 16). This ridge was composed of ice blocks 10 to 15 cm thick. In another somewhat sheltered area off the southeast coast of Isaacs Pt. (Fig. 2) four grounded ice formations were observed, each 4 m or more in height. These formations are shown in Figure 17. The largest one in area was grounded in 2.6 m of water.

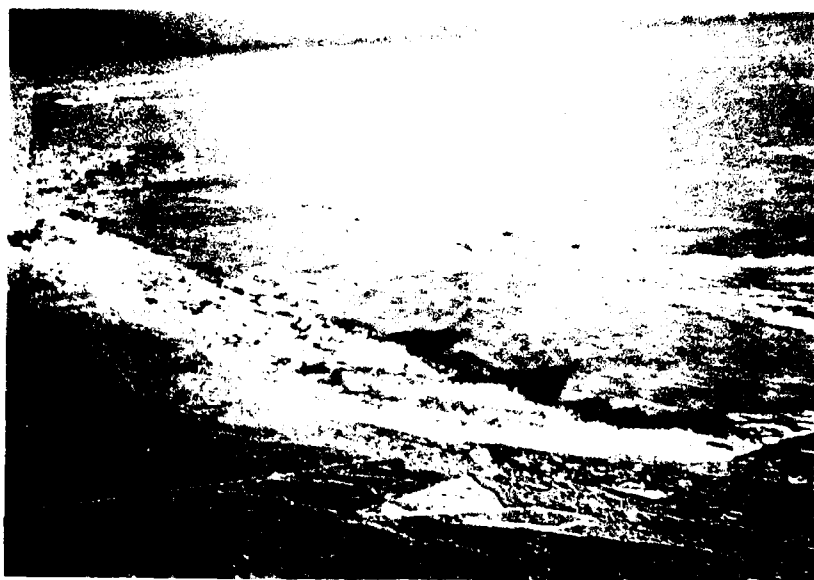
Figure 18. Grounded ice formation west of Cape Denbigh.

Large grounded ice formations were also observed paralleling the 10-m depth contour from Cape Denbigh to Pt. Dexter (Fig. 18), off the coast of Cape Darby, Rocky Point, Cape Nome, and the south side of

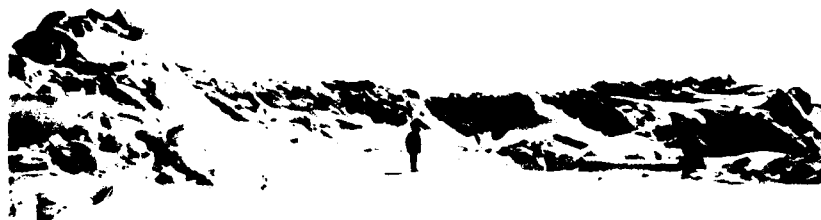
Figure 19. Five-meter-high ice formation grounded in 6.3 m of water off Port Clarence.

Sledge Island, off Port Clarence spit (Fig. 19) and along the coast between Cape York and Cape Prince of Wales.

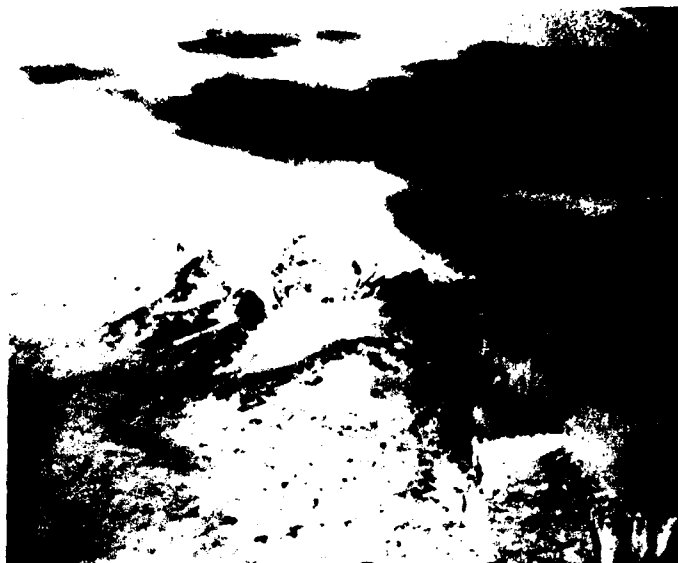
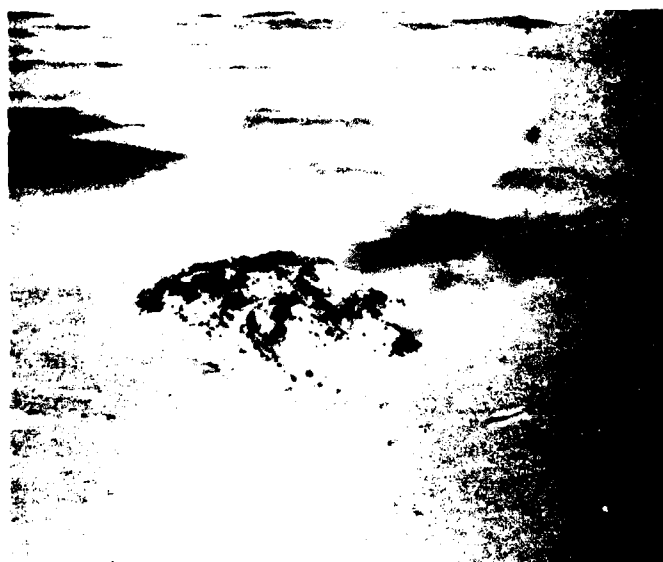
Figure 21. Typical sediment-laden ice ridge formations.

Most of the grounded ice formations were found to be quite dirty (Fig. 21). Some of this material was incorporated into the ice during growth, either by the freezing of silt-laden water or by the incorporation of dirt-laden frazil ice into the growing ice sheet. Drake et al.⁴ have shown that significant suspended sediment exists in the water beneath the ice in the Yukon River Delta region during the winter. However, most of the dirt observed in the ice rubble was the direct result of ice interaction with the sea floor. During ridge-building, portions or fragments of the ice sheet were forced downward against the seabed and then pushed back upward, bringing sediment with them to all parts of the rubble pile. Through this action sediment is gouged up and redistributed by ice or current transport.

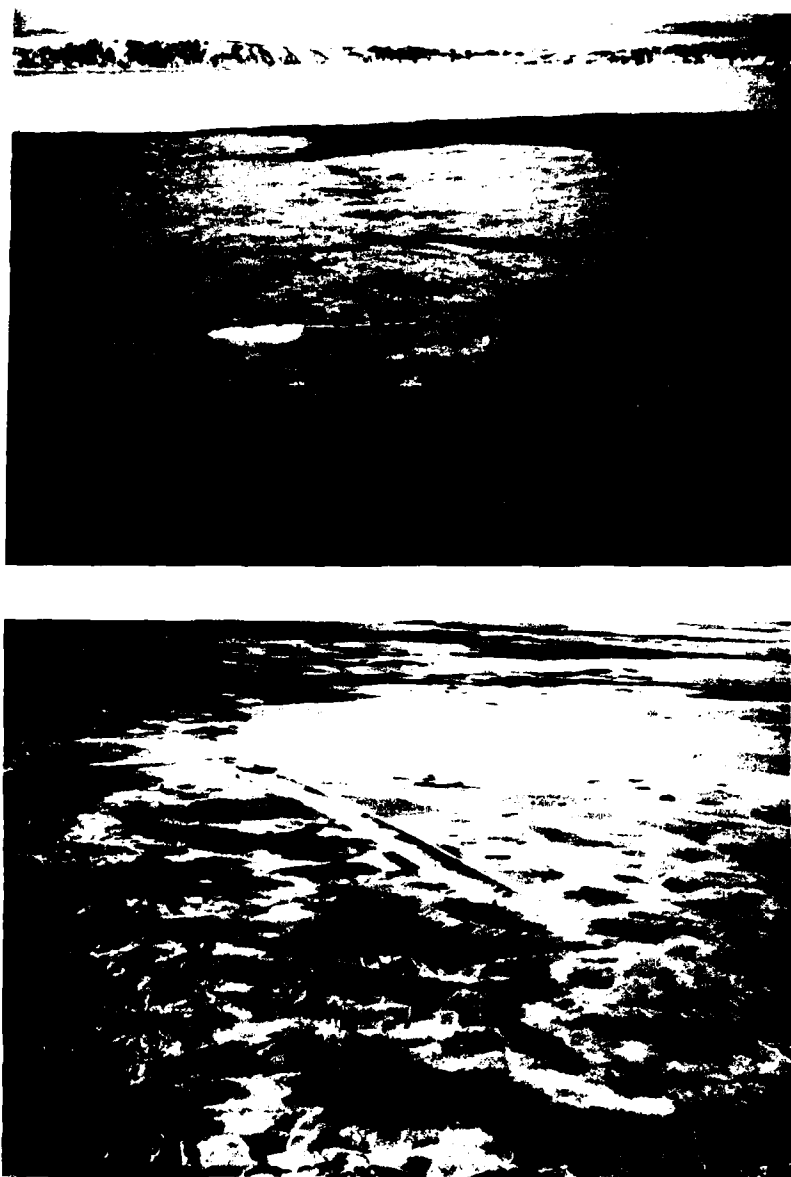
Figure 24. Ice formation believed to be moving with the current through thin ice.

second ice formation (Fig. 23) was observed moving with a broken ice field near position C in Figure 2. Another observed from the air (Fig. 24) appeared to be sailing westward through thin ice west of Rocky Point. However, this was not verified by observations from the fast ice as a landing could not be made. The following personal accounts of large ice formations sailing about are of interest.
